Part 1: 10 Year Service Performance of Composite Oak Flooring
(Performance of first field test kit made by Havco Wood Products)

Date of Inspection:	November 1, 2004
Location:	Schneider National , 34500 LBJ Freeway, Dallas, TX 75241
Reported by:	Gopal Padmanabhan (Engineer, Havco Wood Products)

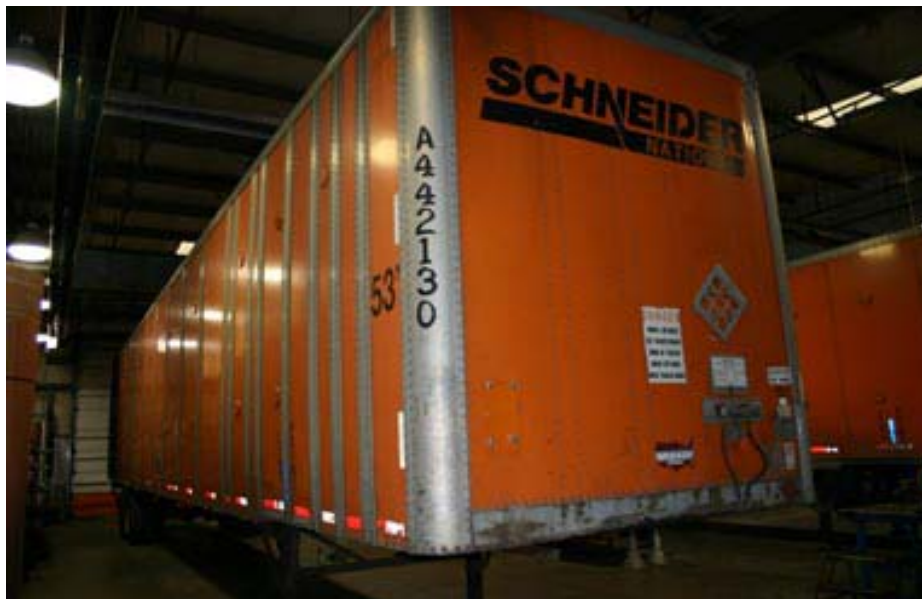
Ten year old trailer with composite flooring.

Flooring of trailer # A442130 (Schneider National) was inspected at the Dallas maintenance facility. This trailer had a manufacturing date of February 24, 1995. The trailer flooring was identified as Havco composite (Version-Field test kit). Floor was composed of 20 foot long or shorter sections of composite boards. These boards were butted together at the ends of boards to

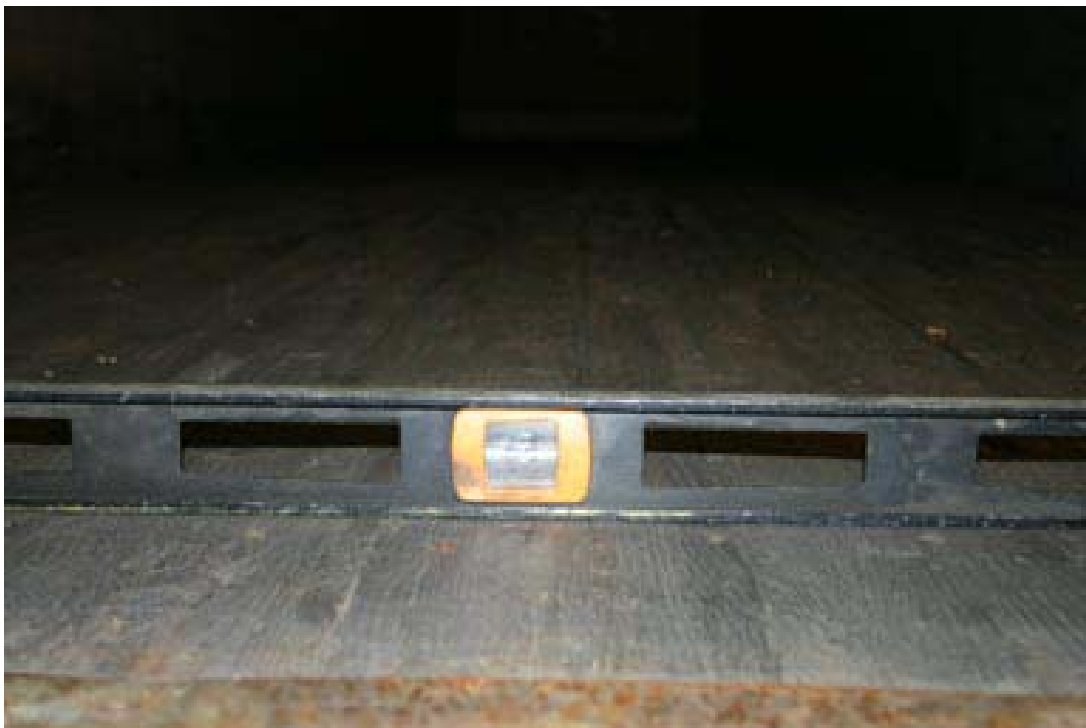
Flatness of composite flooring at a rear section.

Floorboards were found to be flat with no visible warping or cupping. A level was used to check flatness of boards at the rear and forward locations of floor, across mating shiplaps and across butt joints of boards. No abnormalities were found.

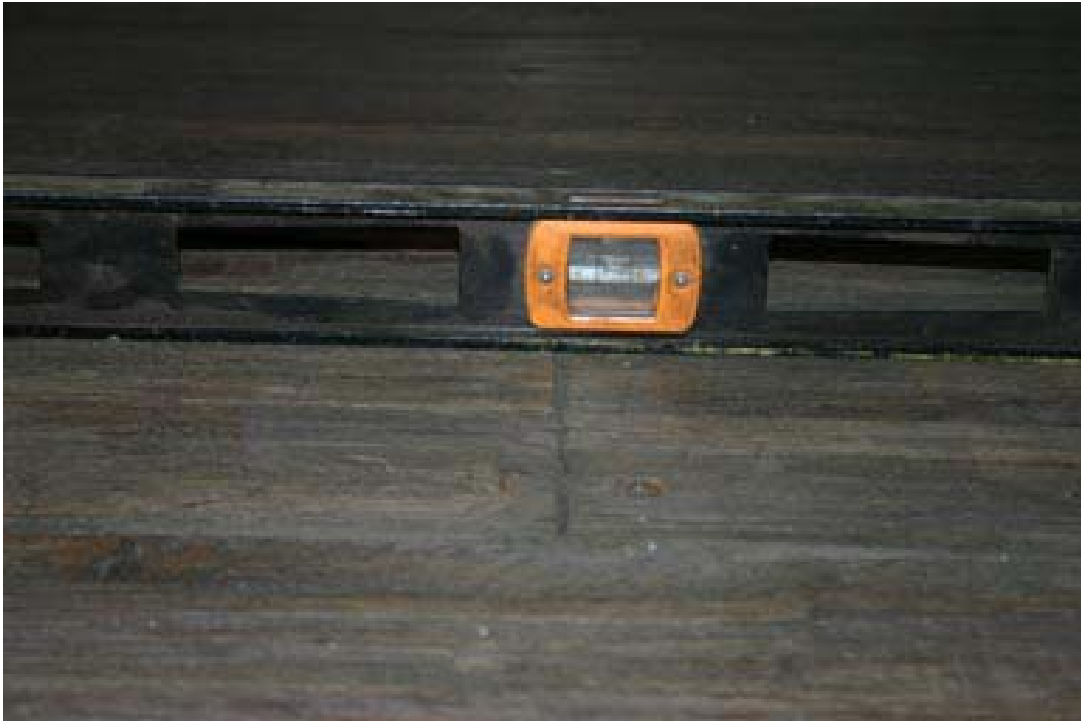
Flatness of composite flooring across a butt joint of boards.

Flooring at and around the butt joints of boards were sound with no sign of any problem.

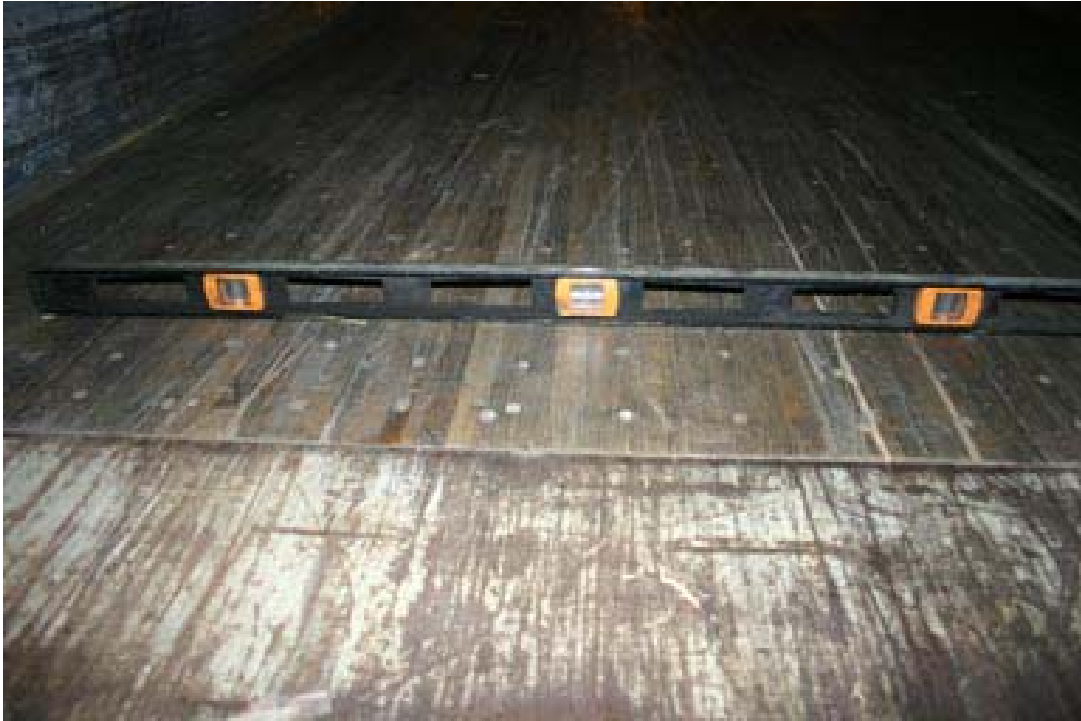
Flatness of composite flooring at a forward section.

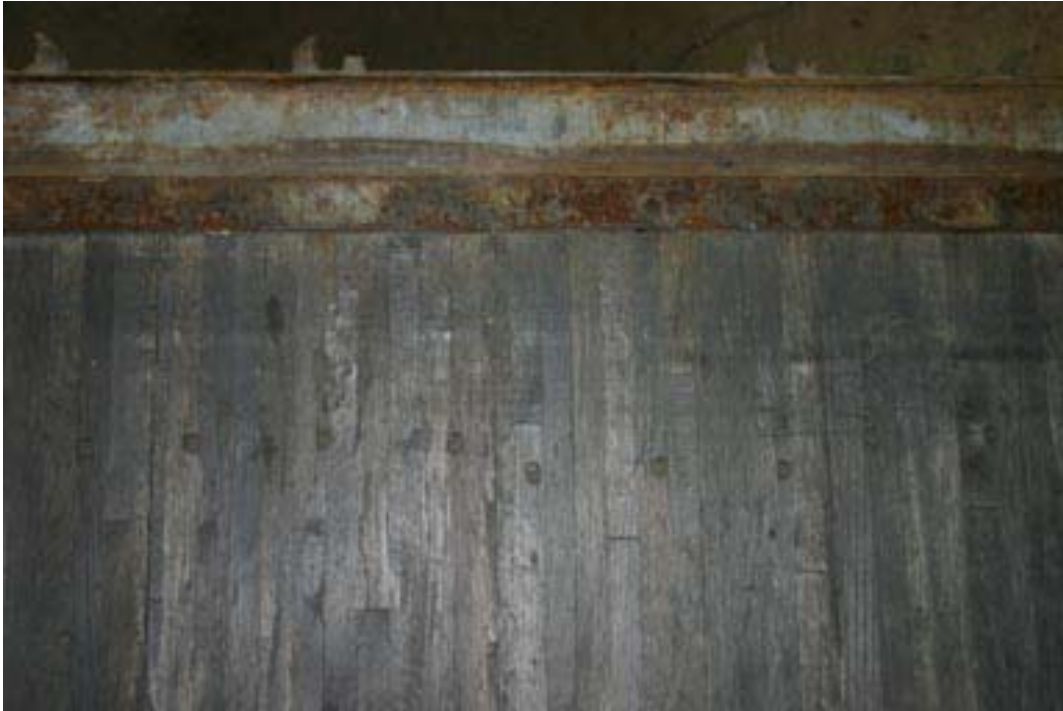
For the first 4 feet of the flooring at the rear location, the top surface of inner boards showed moderate amount of scuffing and wear marks caused during loading/unloading with lift trucks. From the 4 foot to the 12 foot mark at the rear location of flooring, several large and deep gouges were found. A few of these gouges were also present towards the forward location of flooring. The edge boards showed minimal wear compared to inner boards.

From the rear frame to about 12 inches of flooring, surface cracking of flooring at glue lines was noted. For some boards, the cracks were within about 24 inches of the rear frame. These cracks were most likely the result of weathering and exposure to water at the top side of the floorboards. Typically, wetting and drying cycles of wood at the top side of flooring leads to this phenomenon. However, surface cracking did not lead to breakage of boards/wood or the fiberglass reinforcement at the bottom side of boards. Clearly, the glue line cracks did not extend

through the thickness of the boards. The rest of the flooring away from the 24 inch rear location showed no visible cracking.

Top side of rear section of composite flooring.

Damage to composite flooring is more likely to happen at the top side of flooring in the form of gouges and surface cracking at rear location due to weathering. A sealant applied to the top side for about 3 feet of flooring should reduce the effects of weathering and prolong life. Prevention of gouging needs careful operating procedures during loading/unloading, which can be difficult to implement on a consistent basis.

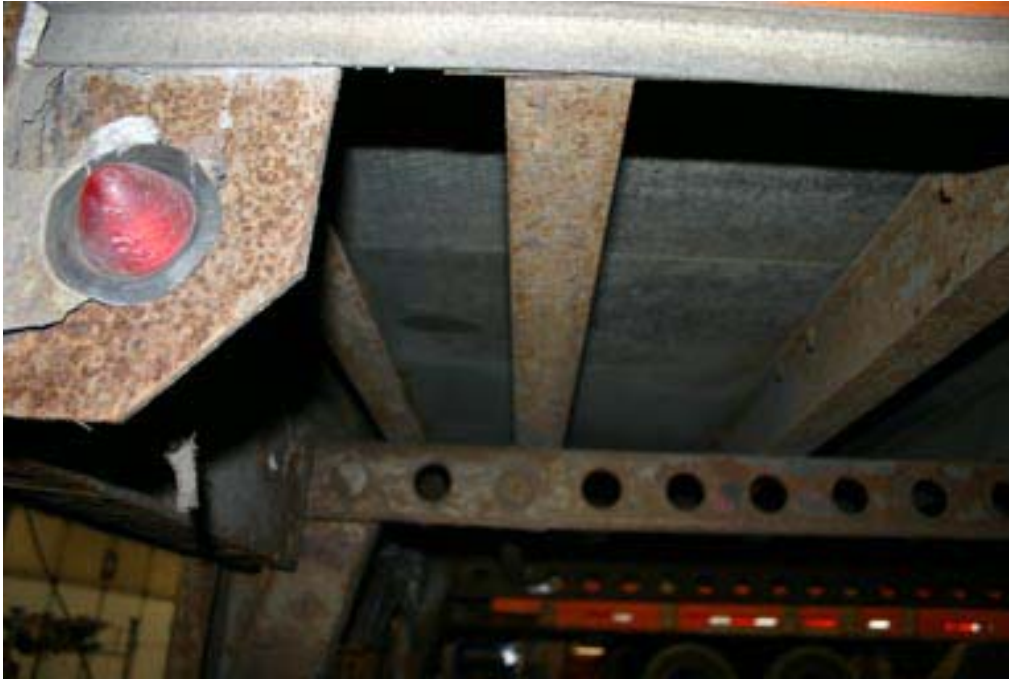
Bottom side of flooring was in excellent condition and showed no breakage or fracture of fiberglass reinforcement. The rear 12 to 24 inch section of flooring, which had surface cracking of gluelines on the top side (from weathering), showed no visible effect at the bottom side. The fiberglass layer of this section appeared as good as the other sections of the flooring.

Very few nails (less than a dozen) were seen protruding through the floor. The fiberglass layer was punctured at the tips of the nails and split along the length of board for about half an inch. There was no growth of damage originally caused by the nails.

Underside of composite flooring at the rear section.

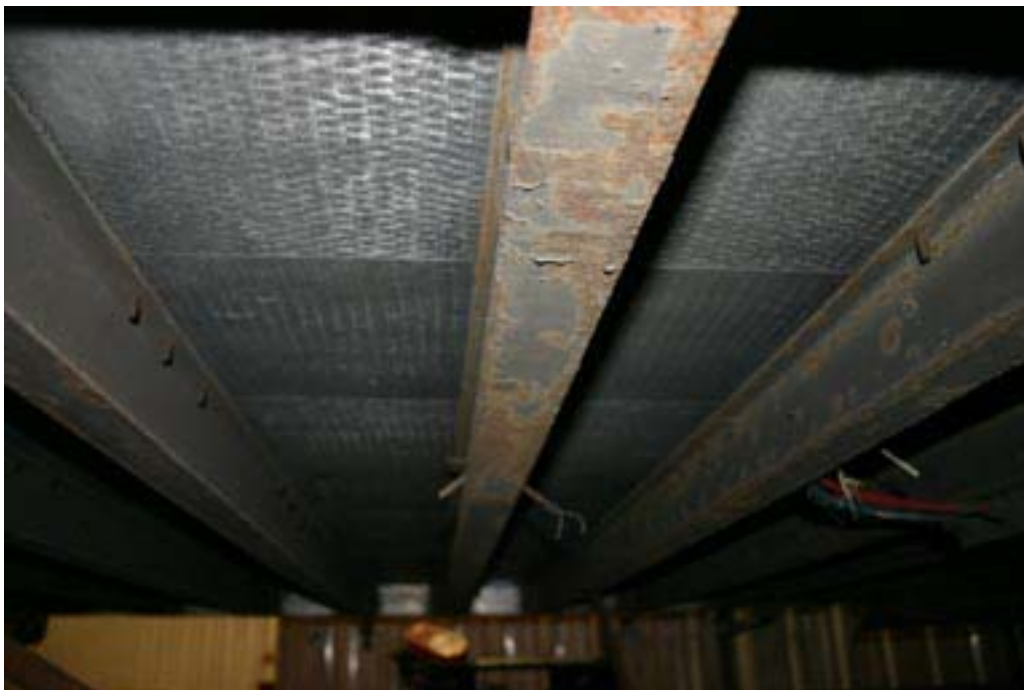
Underside of composite flooring in the bay section.
