Part 2: Strength of 10 Year Old Composite Oak Flooring

(Testing of first field test kit made by Havco Wood Products)

Location:	Havco Wood Products, Scott City, MO 63780
Reported by:	Gopal Padmanabhan (Engineer, Havco Wood Products)
Date:	April 7, 2005

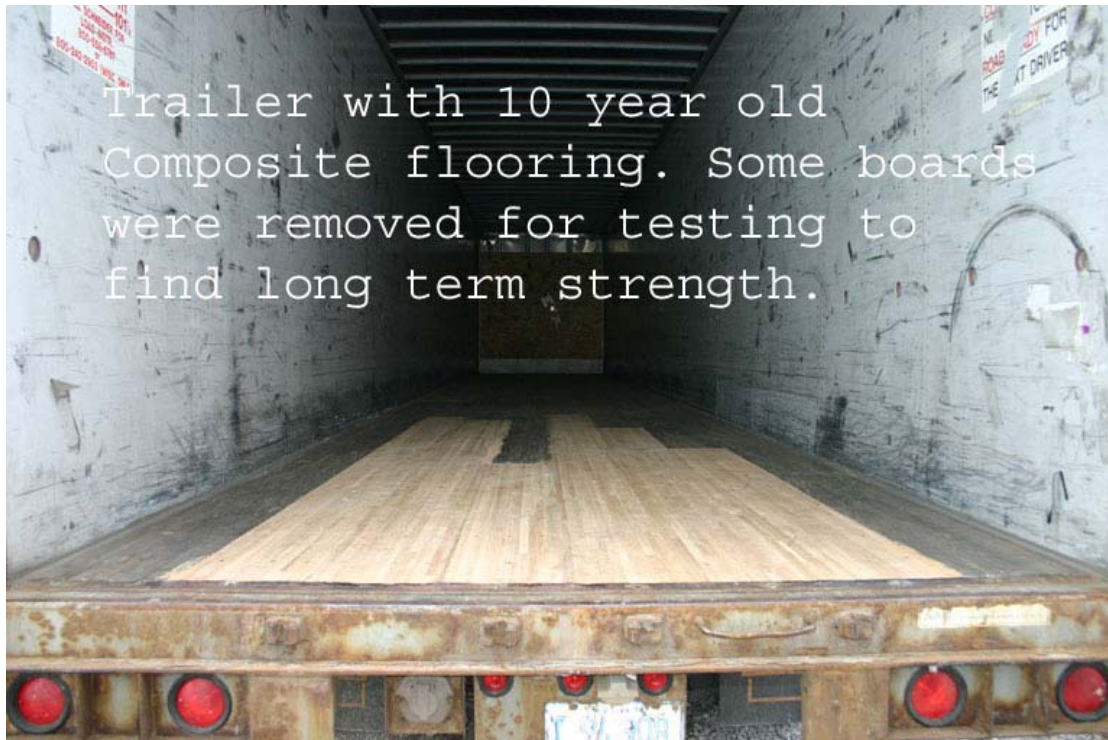
10 Year Old Composite Flooring

Flooring of trailer # A442130 (Schneider National) was previously inspected at the Dallas maintenance facility. This trailer had a manufacturing date of February 24, 1995. The trailer flooring was identified as Havco composite (Version-Field test kit). Floor was composed of 20 foot long or shorter sections of composite boards. These boards were butted together at the ends of boards to span the length of the floor. Based on the date and construction of flooring, this floor kit was identified as the first composite oak flooring ever made for field testing by Havco Wood Products.

This trailer was brought over to Havco's factory in Missouri in March 2005. The floor was 10 years old at the time of this inspection and testing. Several boards in the rear section of trailer were removed for inspection and testing. The thickness of the flooring was 1 3/16", with a nominal thickness of fiberglass of 1/16".

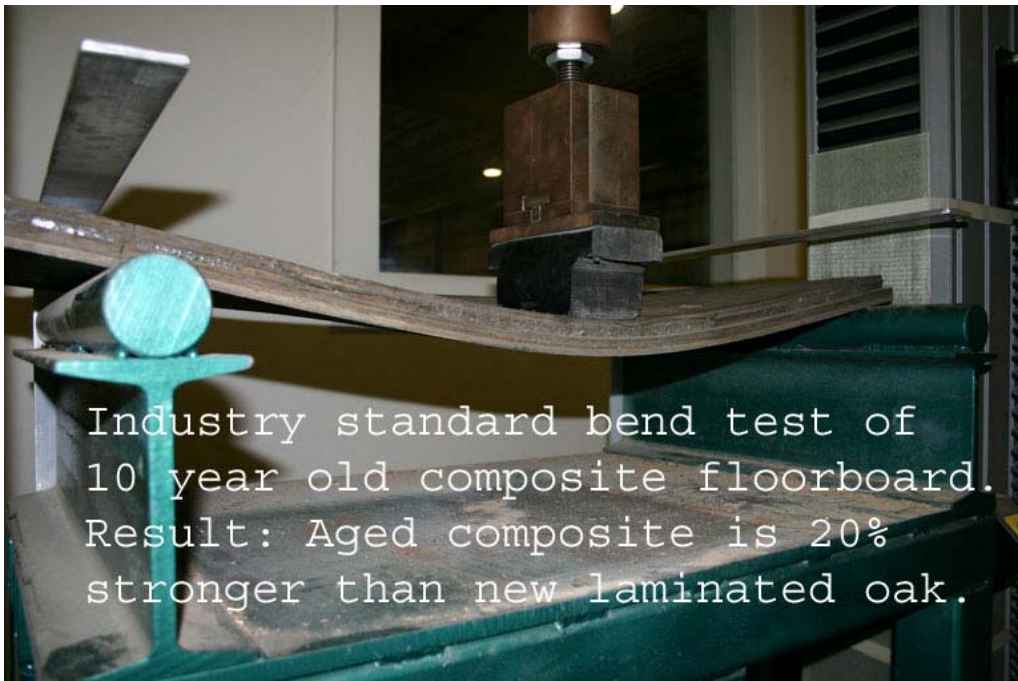
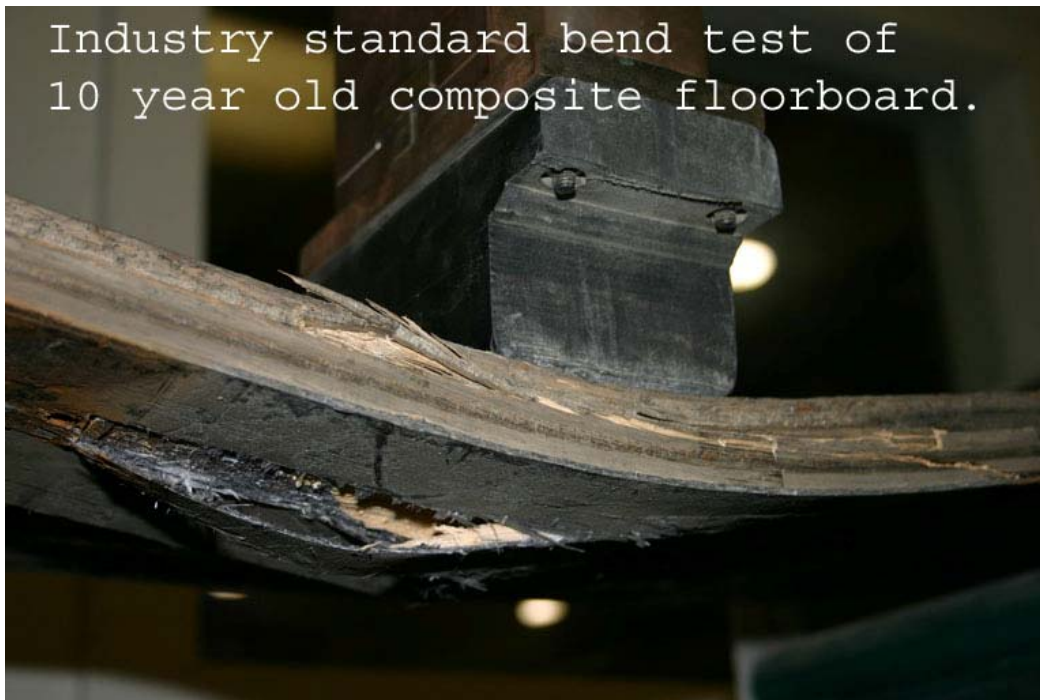
Industry Standard Bend Testing

The industry standard bend test requires the application of bending load at an edge of floorboard supported at 30 inch span. A hard rubber block with a foot print of 3"x4" is used to transfer the load. This test is normally used to check the production quality of glue bonds between wood components that make up the floorboard. The average failure load obtained from this test is a measure of the load carrying ability of the flooring.

Based on this test, the 1 3/16" composite floorboard showed a 22% loss of strength after 10 years of service compared to its original strength. Specifically, the residual average failure load was 6166 lbs compared to 7883 lbs for the original virgin floorboard. A 1 5/16" standard oak floorboard has an average strength of 5100 lbs in new condition. It is clear that the 10 year old 1 3/16" composite floorboard is about 20% stronger than new standard oak floorboards.

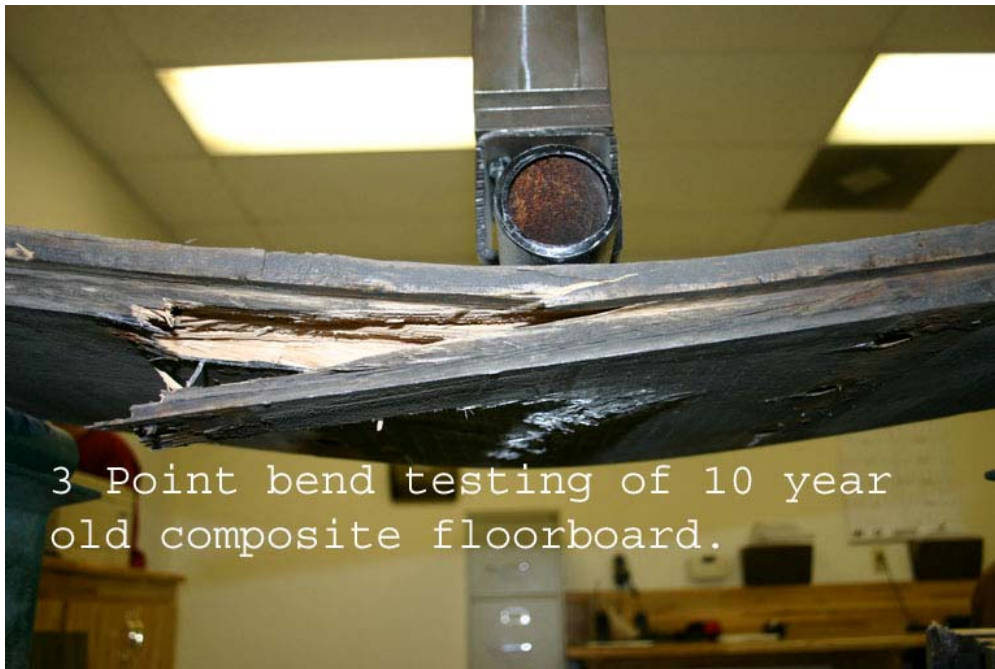
This test is conducted to determine the material strength and stiffness factor (modulus) of flooring. Results show that the 10 year old composite flooring is stronger than new standard oak flooring.

3 Point bend testing of 10 year old composite floorboard.

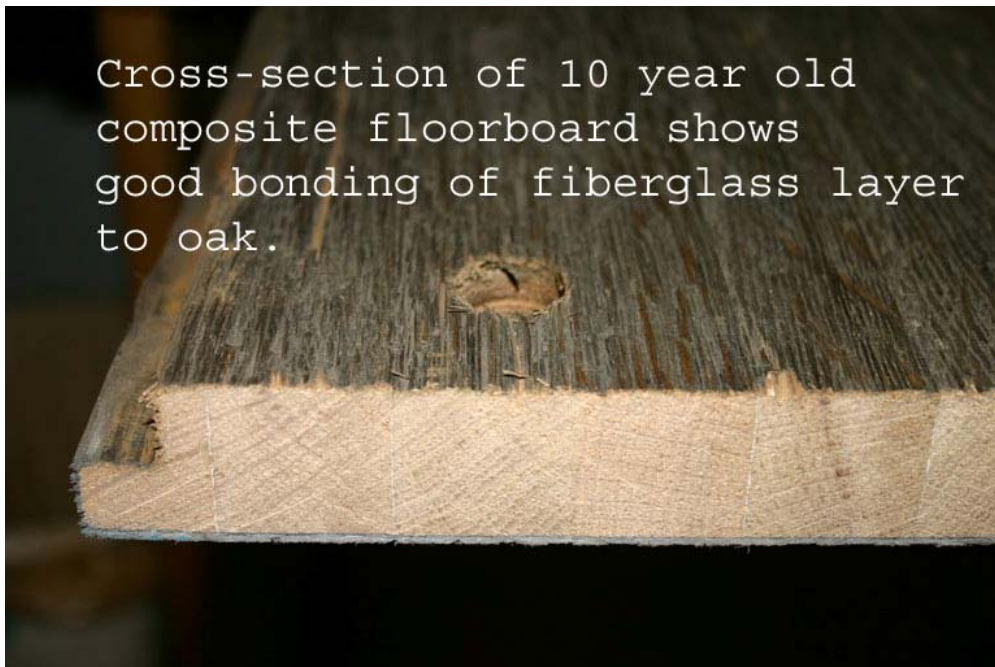
Cross-section of 10 year old composite floorboard shows good bonding of fiberglass layer to oak.

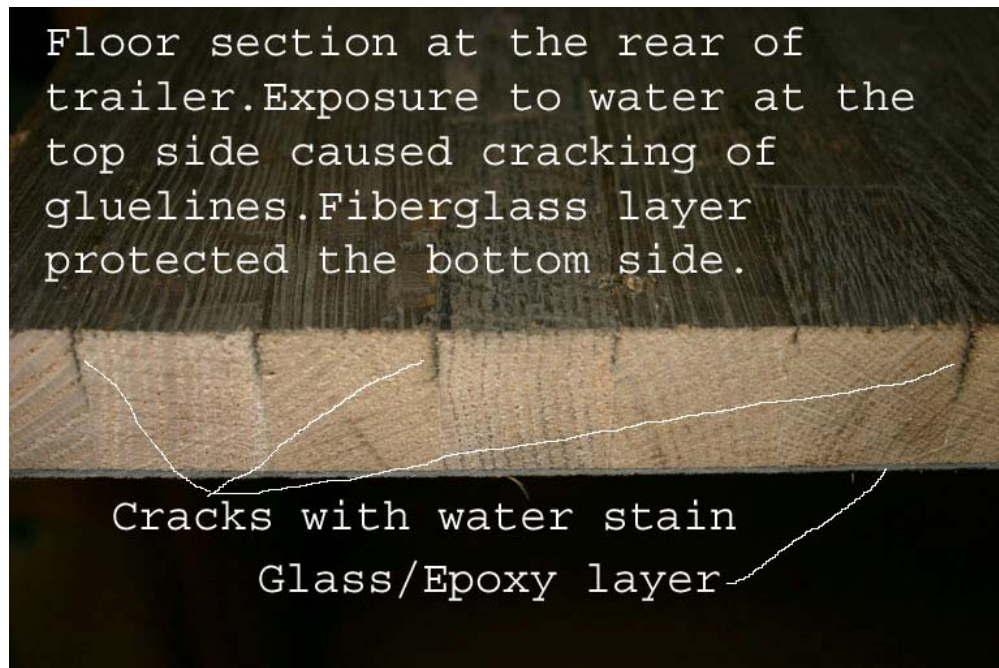
Cross-sections of the 10 year old composite floorboards were examined to determine the effects of water. At the rear section of flooring near the doors, the gluebonds between wood components showed cracks at the top side of flooring. However, the bottom side was not affected by water. At cross-sections away from the doors, the composite floorboards were in good condition.
