Part 2: Strength of 10 Year Old Composite Oak Flooring

(Testing of first field test kit made by Havco Wood Products)

Location:	Havco Wood Products, Scott City, MO 63780
Reported by:	Gopal Padmanabhan (Engineer, Havco Wood Products)
Date:	April 7, 2005

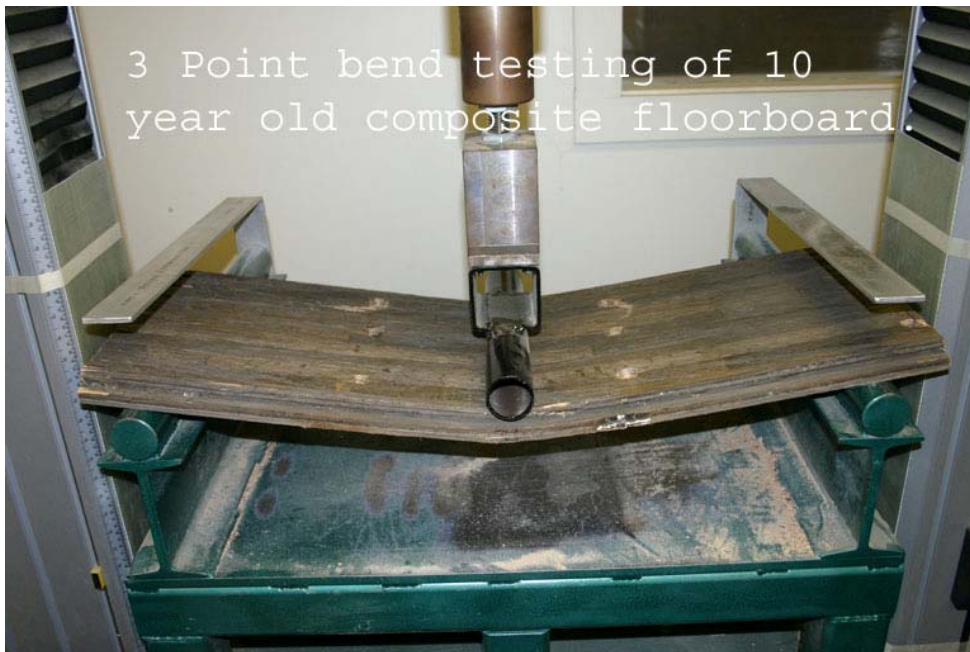
This test is conducted to determine the material strength and stiffness factor (modulus) of flooring. Results show that the 10 year old composite flooring is stronger than new standard oak flooring.

Flooring Type	Strength (psi)	Modulus (million psi)
1 3/16" Composite (New test boards before road service)	20,964	1.97
1 3/16" Composite (After road service for 10 years)	16,234	1.64
1 5/16" Standard Oak (New)	13,000	1.65
1 3/16" Havco Composite (New)	24,000	2.1
